# Manhole Inspection Summary

Manhole # S25EE1024MH

Insp Date: **1/26/07 11:29 AM**

**Location** Address: **3803 HICKORY AVE**

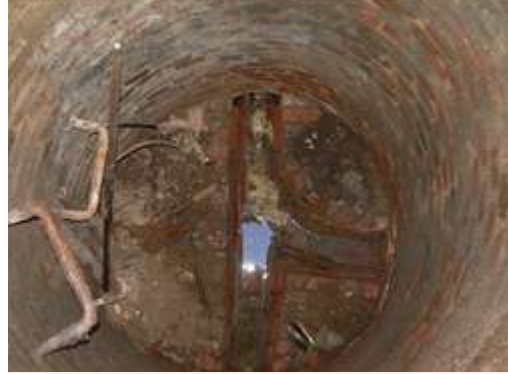
Top View

Evidence of surcharge - Bench debris. Channel debris. Corroded and missing steps.

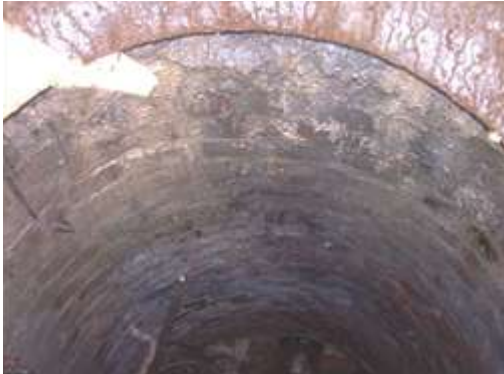
Defect

Adjustment infiltration. Corbel infiltration.

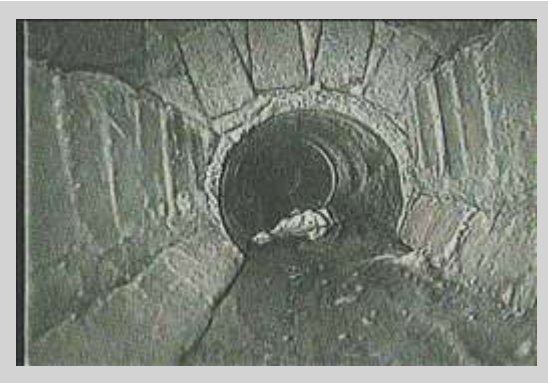
### 8 in. Circular Gravity Sewer Pipe Out @ 12 O'Clock

Channel deterioration.

Deposits: ☐ None ☒ **Mud** ☐ Sludge ☒ **Debris** ☐ Grease

Silt Depth: **0.5** (in.) Deposits Extent: **Light**

Infiltration: **None** Pipe Seal Cond: **Cracked**

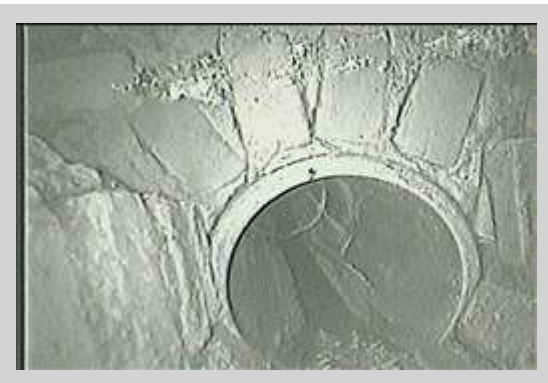
### 8 in. Circular Gravity Sewer Pipe In @ 3 O'Clock

Deposits: ☐ None ☒ **Mud** ☐ Sludge ☒ **Debris** ☐ Grease

Silt Depth: **0.5** (in.) Deposits Extent: **Light**

Infiltration: **Evidence** Pipe Seal Cond: **Cracked**

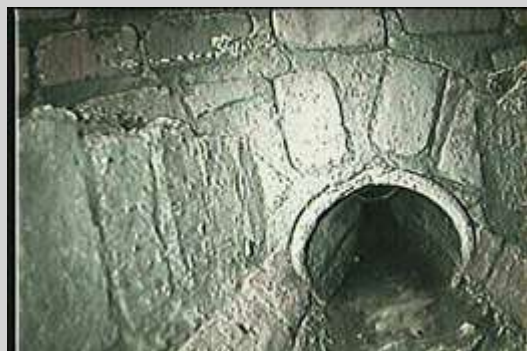
8 in. Circular Gravity Sewer

Deposits: ☐ None ☒ **Mud** ☐ Sludge ☒ **Debris** ☒ **Grease**

Silt Depth: **0.5** (in.)

Deposits Extent: **Light**
